ABC COMPANY
Roof Area 1

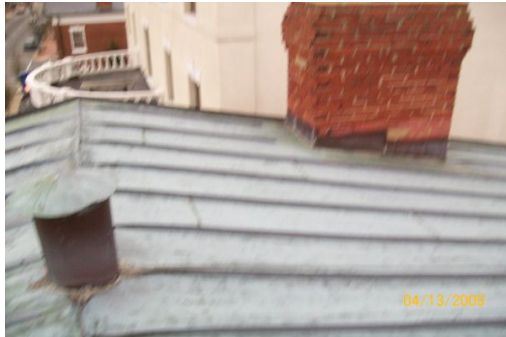
Chimney (typical)

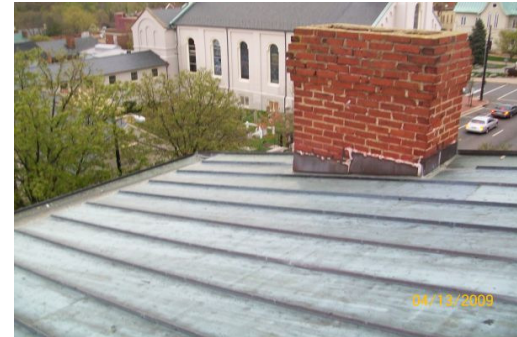
Chimney (typical)

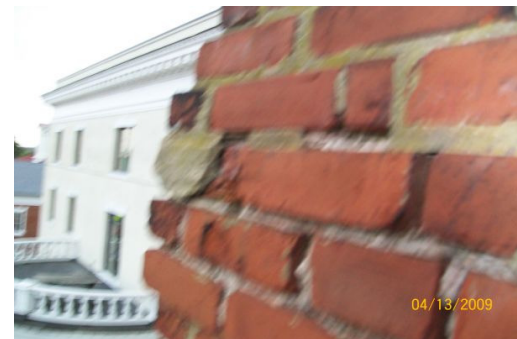
Chimney Masonry Failing
(typical)

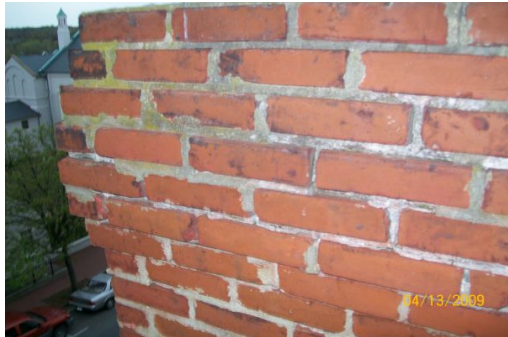
**Chimney Masonry Failing
(typical)**

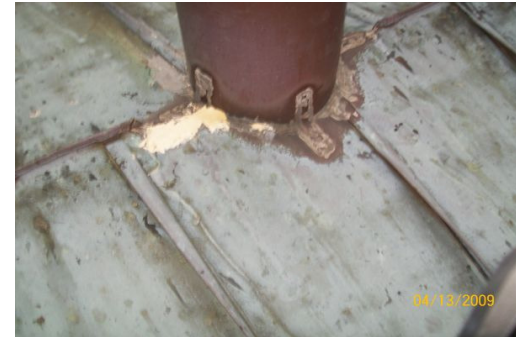
**Vent Cracking
at roof to base transition**

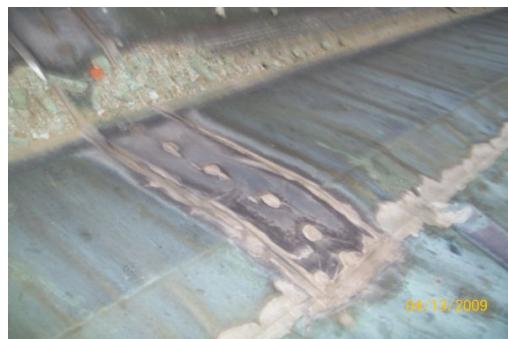
**Copper seams failing
(typical)**

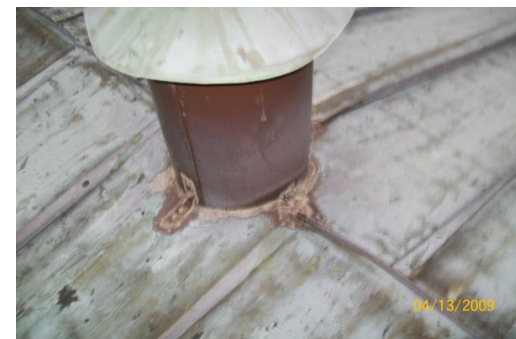
**Vent Cracking
at roof to base transition**

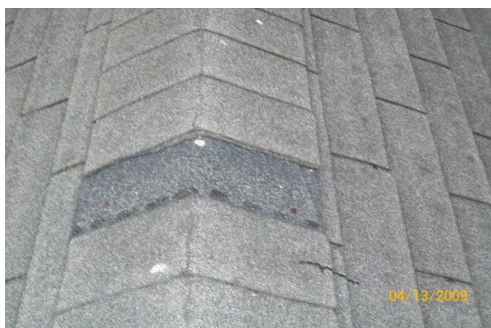
Roof 2 Missing Shingles
(typical)

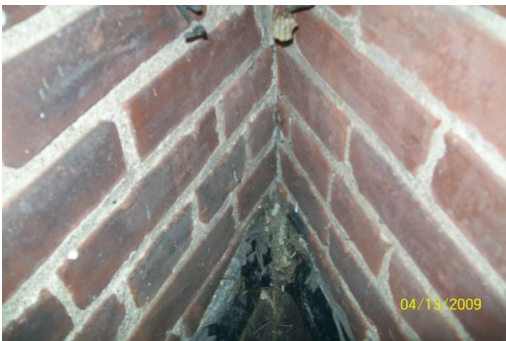
**Flashing Failing in
Wedge Corner**

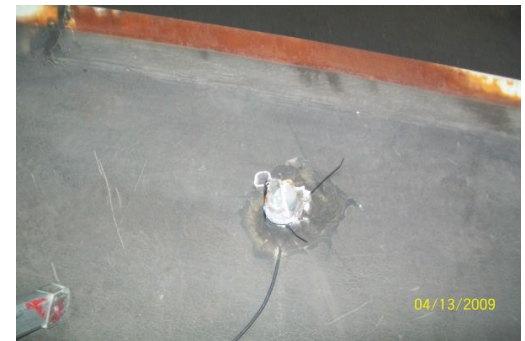
Missing Cap on Vent
